December 2015

Grantee: Lewistown Borough
Grantee Contact: John White, Borough Manager
East Third Street
Lewistown, PA 17044
Consultant: Ann E. Yost, RLA
YSM Landscape Architects
19 South Newberry Street
York, PA 17401

The purpose of this study is to evaluate the existing conditions of Lewistown Recreation Park and define opportunities and ideas that will revitalize the park and enhance it as a community recreation asset. Lewistown Recreation Park, known locally as Rec Park, is the hub of recreation activities in the Borough. The 26 acre property is home to the Lewistown Community Center, the swimming pool, walking trails, and numerous athletic fields and courts.

Prepared for:
Lewistown Borough

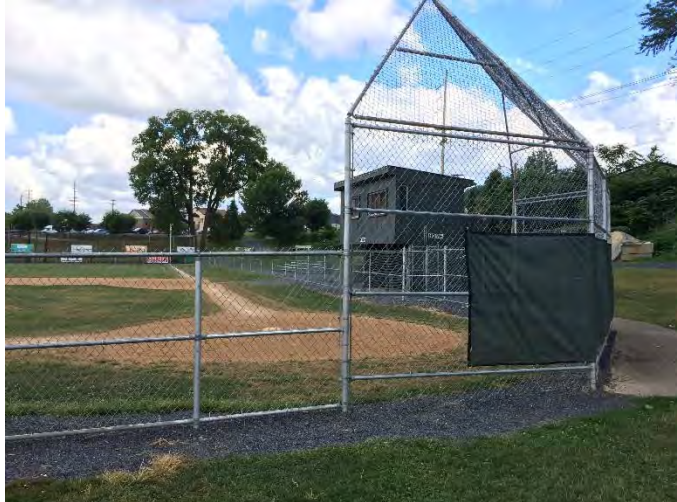
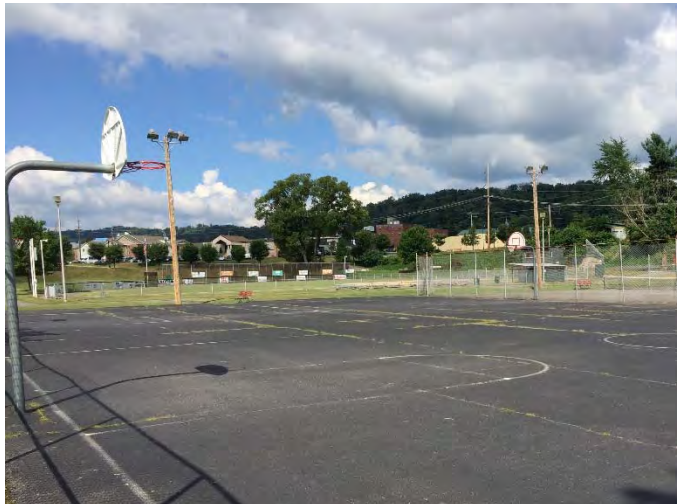
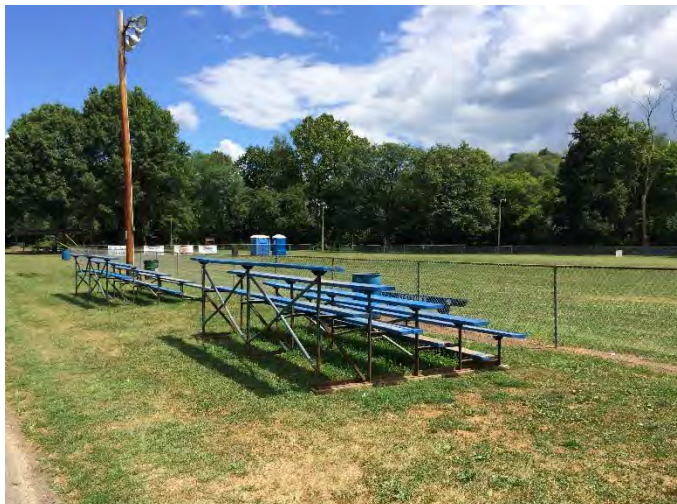
- Football Field – A football field is located in the northeast portion of the park, close to the East Chestnut Street Extension entrance. The field has a northeast-southwest orientation that is acceptable, but off of the preferred north-south orientation. The field is surrounded by a 3-foot high chain link fence. Wooden benches area provided and bleachers are located on the northwest side of the field. A portable shed is used for storage and concessions.

- Soccer Field – A U-12 size (150' x 240') soccer field is located between the adult baseball field and football field. The soccer field has a northeast-southwest orientation,

closer to east-west than the football field. While this orientation is not preferred, the configuration of the tract and available space does not allow the preferred north-south orientation to be achieved.

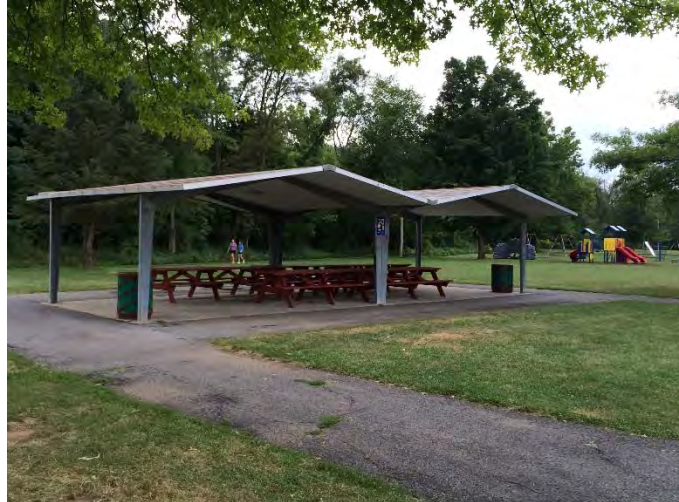
- A medium picnic pavilion is located opposite the swimming pool building on the south side of the park. The pavilion can accommodate approximately 8 picnic tables.

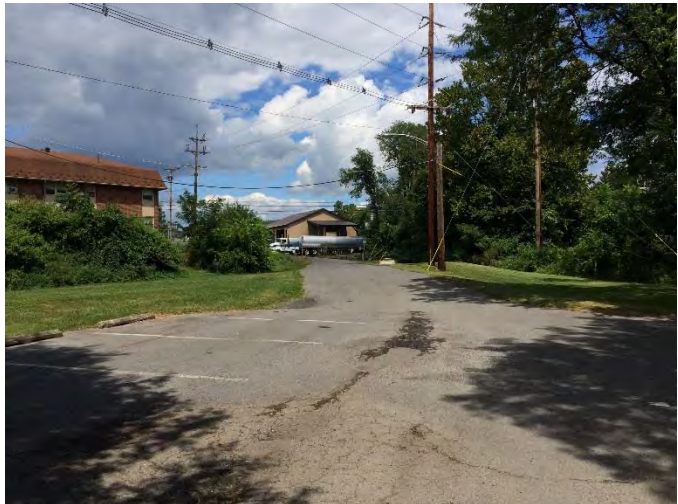
- Access Drives and Parking – Three access points and paved parking areas are provided for Rec Park.
 - The main entrance is via Cherry Street which extends as a drive into the park site. The drive separates the adult baseball field and the swimming pool and extends to the center of the site where it turns west into a large parking area. The parking is located between the swimming pool and basketball courts to the north and the large picnic pavilion and playground to the south. The parking area accommodates approximately 145 vehicles, including five accessible spaces.

- A small parking area is elevated at the intersection of South Dorcas Street and Montgomery Avenue and access drives extend to each street. This parking area accommodates approximately 17 vehicles, including two accessible spaces.

- A drive from East Chestnut Street Extended, extends into the park to a small parking area accommodating approximately 20 vehicles plus one accessible space.

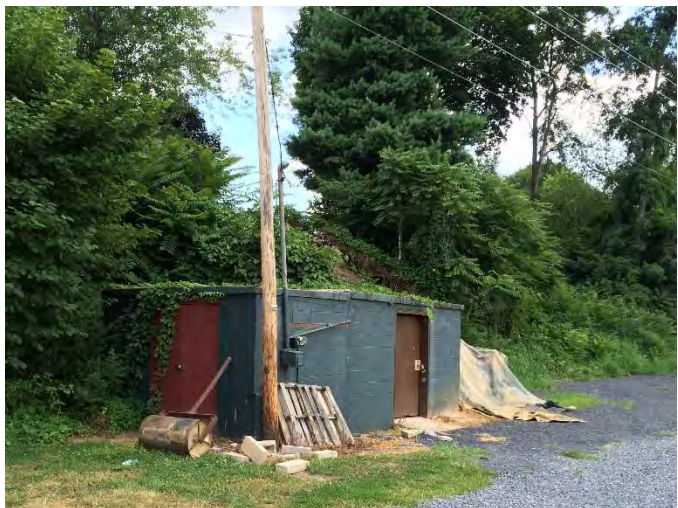
- Batting Cages – Two batting cages are located west of the youth baseball fields. The batting cages are open pole structures with netting.
- Material Storage Buildings – A block storage building is located along the embankment, north of the youth baseball field. The building is in disrepair and materials and equipment are placed around the building, suggesting that it is not large enough to store necessary equipment and materials. The interior of the building was not viewed.

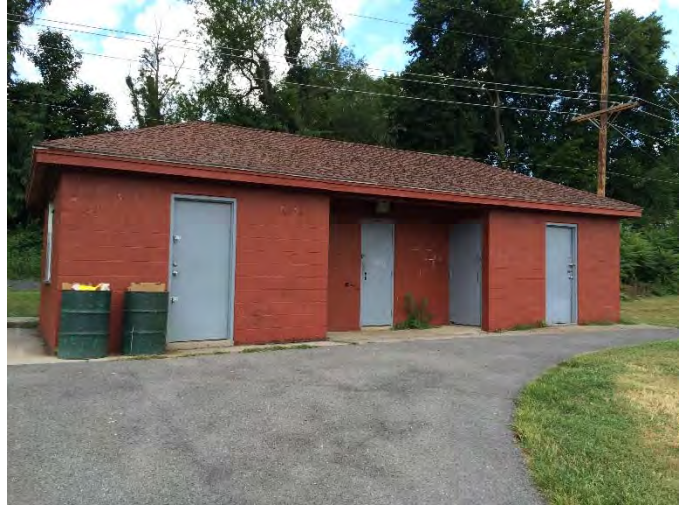
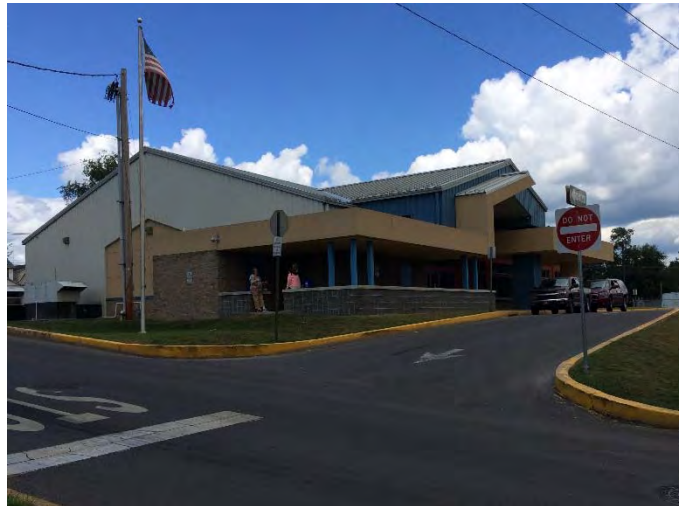
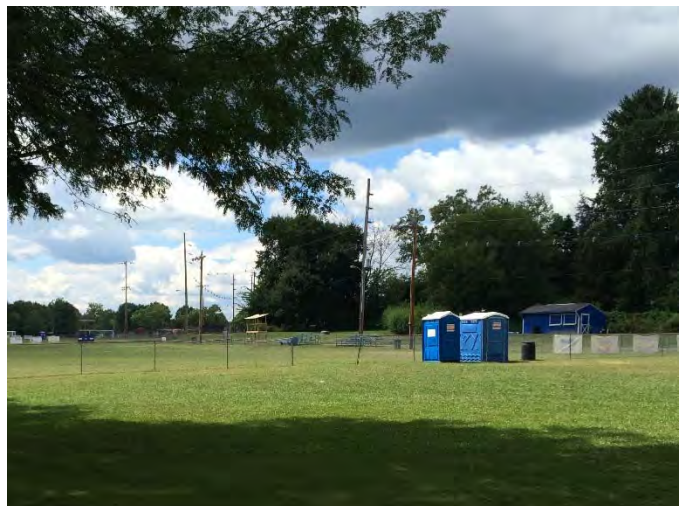
- Portable Toilets – Three portable toilets were located in the eastern end of the park; two at the football field and one at the soccer field.
- Overflow Parking Area – Met-Ed has an electrical sub-station located on the property east of the community center. This property is primarily open and extends to Montgomery Avenue. Overflow parking occurs on the parcel during sports games and tournaments.

- Overhead Electric Lines – An overhead electric line on wooden poles parallels the northern boundary of the park.
- Sanitary Sewer Line – Sanitary sewer manholes were noted along the north property line, indicating that a sanitary sewer line parallels this boundary. A survey is not available to verify the location and size of the sewer line.

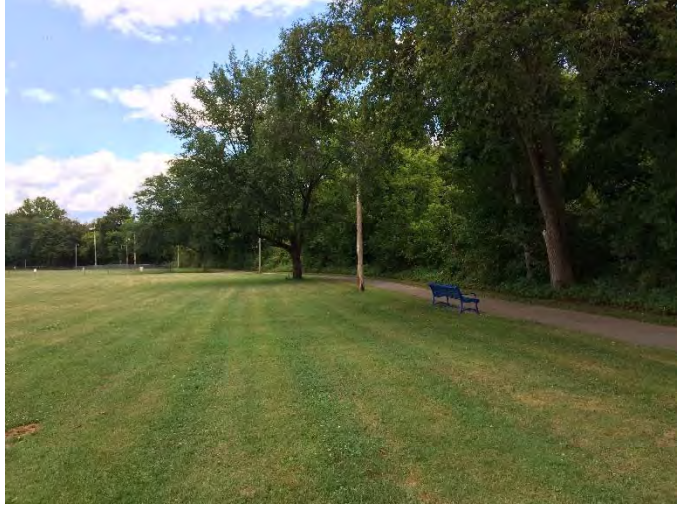
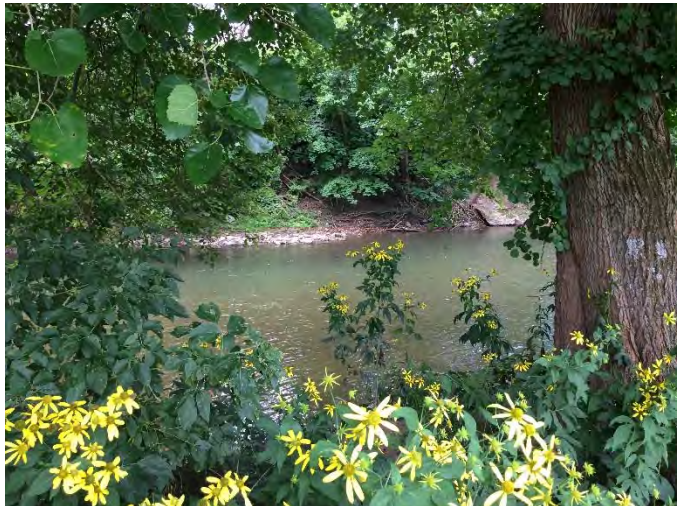
- Kishacoquillas Creek / Drainage – The Kishacoquillas Creek is located to the east and south of the park site and runoff is directed as sheet flow toward the creek. The embankment for the Route 322 exit ramp and East Charles Street separates the park from the creek with the exception of approximately 500 linear feet of the stream located closest to South Dorcas Street. Drainage culverts carry water to the creek beneath these roadways.

- Flooding – Seasonal and severe event flooding affects the park site. Waters from the Kishacoquillas Creek overflow its banks and back up in culverts under East Charles Street and the Route 322 exit ramp into the park.

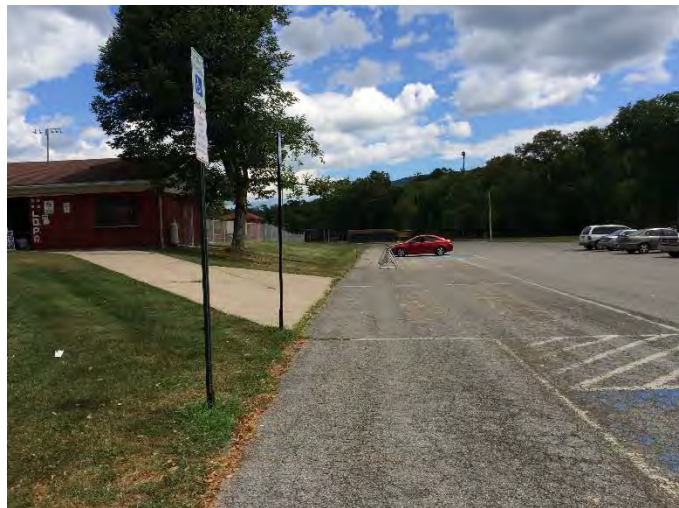
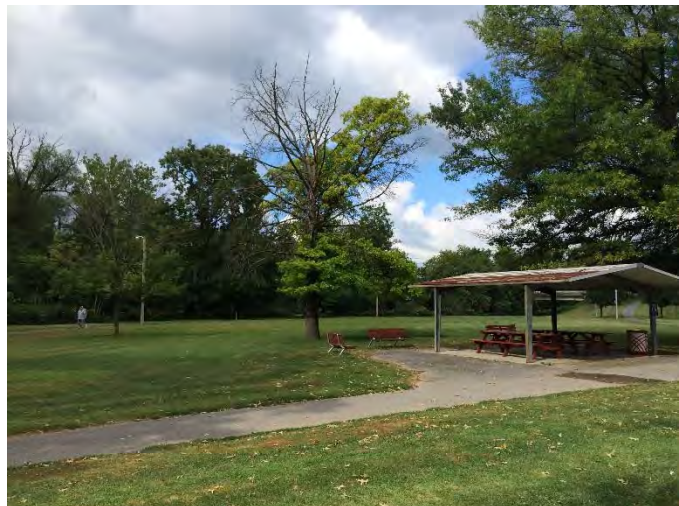
- Install cross walks at locations where the walking trail crosses the entry drive.
- Improve the playground to be age-segregated. Age-segregation

separates children into two play areas; one for 2-5 year olds and a second area for 6-12 year olds. Age-segregation is recommended by the Consumer Product Safety Commission Guidelines for Playground Safety.

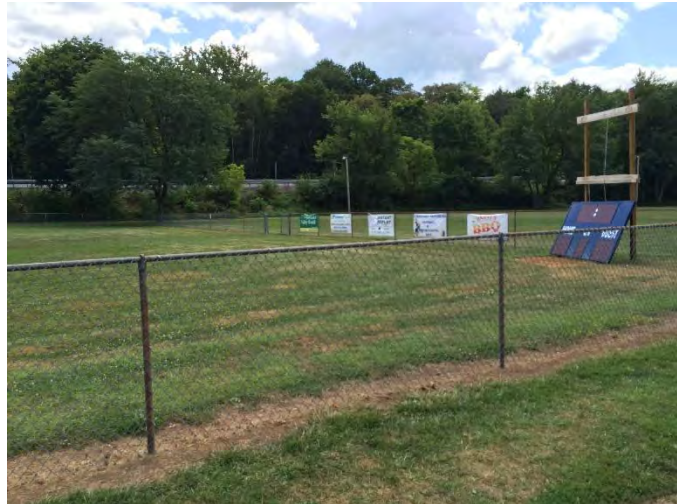
- Remove, replace, or paint rusty chain link fence. Fencing is a visual distraction and not desired in floodplain areas as fence will trap debris during storm events. Prioritize removing fence that is not necessary for safety or functional reason. Removal will have an overall positive impact by opening up more area in the park, limiting visual clutter, and lower maintenance costs associated with mowing at fence lines and ongoing fence repair and upkeep. Remove the chain link fence at the football field. (ST)

- Remove the chain link fence along the northern property line in the area of the football and soccer field. (ST)
- Remove the abandoned softball backstop. (ST)
- Paint or replace the pavilion roofs. (MT)
- Add color throughout the park. In addition to the site furnishing, consider adding shade sails, color metal roofs on pavilions, and perennial and ornamental grass planting areas. (ST)

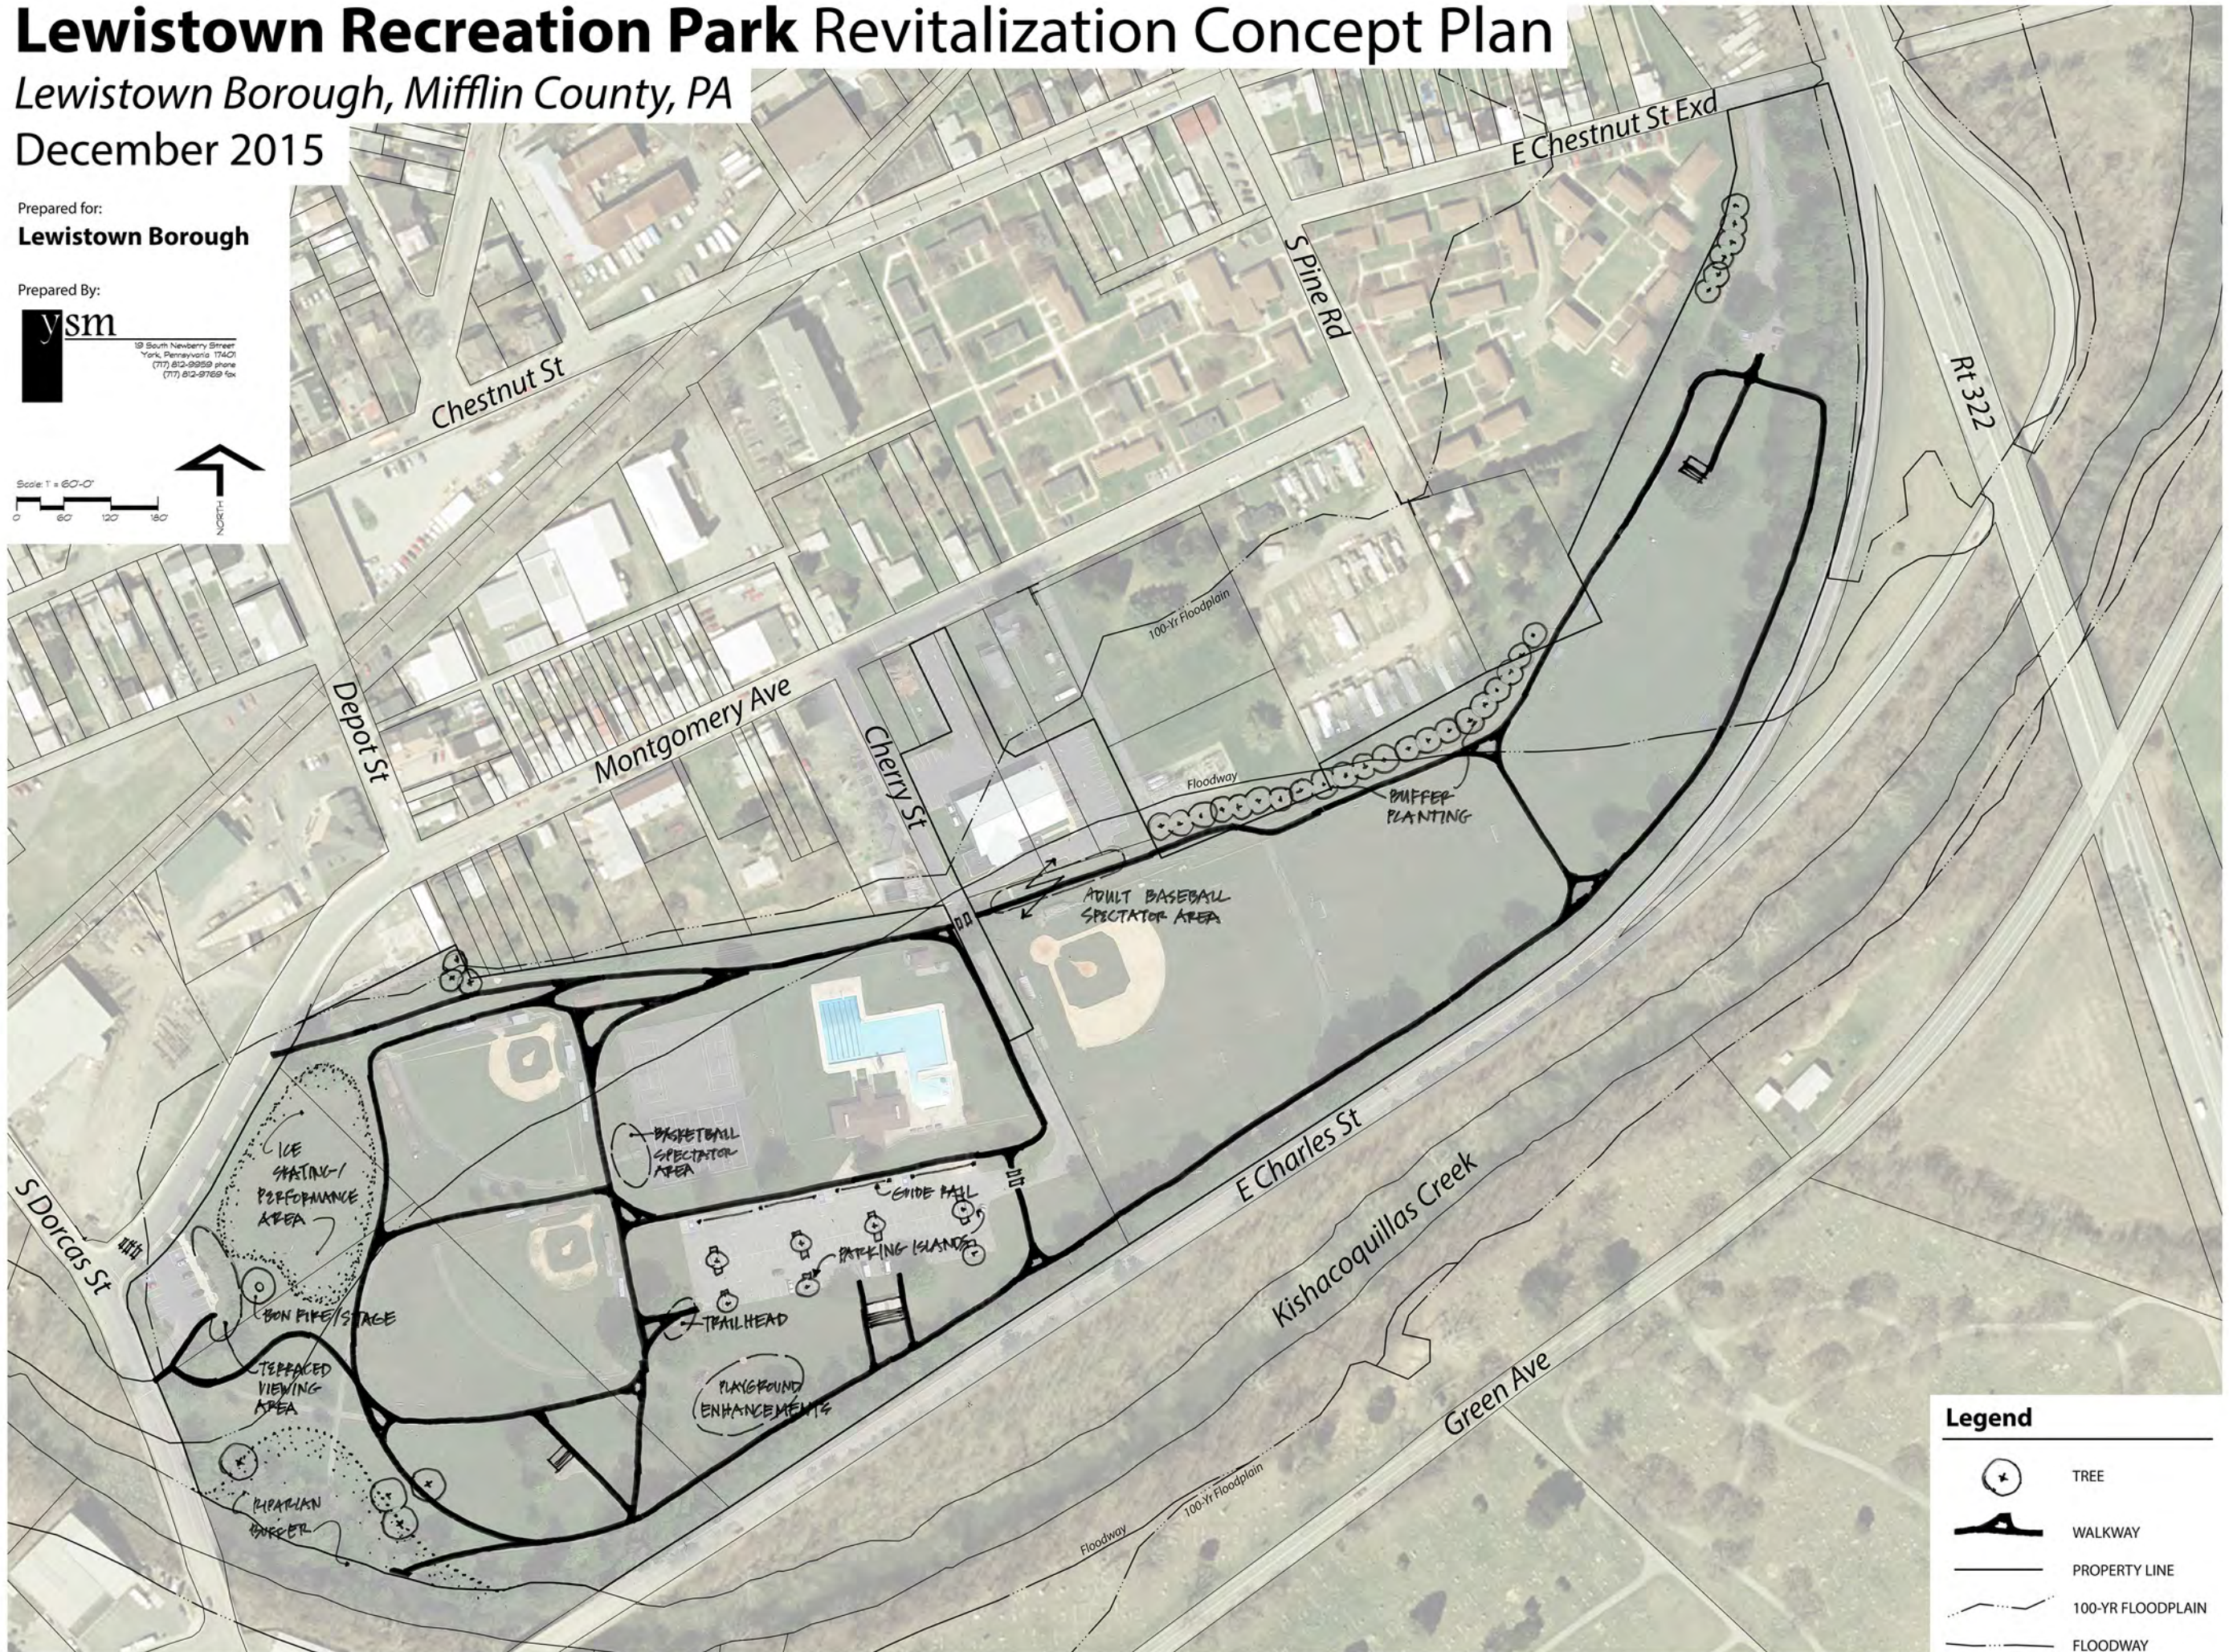
Legend	
	TREE
	WALKWAY
	PROPERTY LINE
	100-YR FLOODPLAIN
	FLOODWAY
